# Access Compliance Report Public Rights-of-Way (Curb Ramps)

Main Street: **CARTHAGE\_ST** Cross Street: **CAIRO\_CIR** Location: **SW**

ADA ID: **RPAT210917140702** Ramp Type: **Type 1 - Perpendicular Diagonal Initial Pass/Fail: Pass** Overall Compliance: **No** Severity Score: **5**

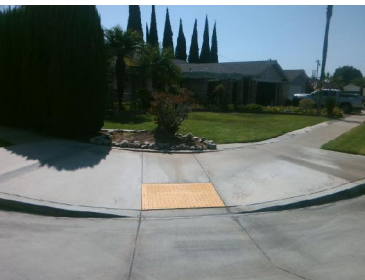
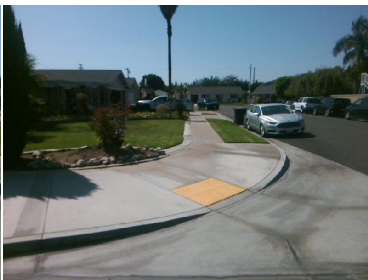
| Compliance | Description | Data | Compliance | Description | Data |
|---|---|---|---|---|---|
| Yes | Gutter Ponding | No | No | Curb Slope | 7.9 |
| No | Gutter Run Slope (%) | 6.5 | | Road Cross Slope (%) | 0.1 |

**Remove & Replace Curb Ramp With Two New Directional Ramps or Equivalent. Remove & Replace Gutter.**
