# Access Compliance Report Public Rights-of-Way (Curb Ramps)

Main Street: YORBA\_LINDA\_BLVD Cross Street: CARTHAGE\_ST Location: NW

ADA ID: RPAT210917141550 Ramp Type: Type 1 - Perpendicular Diagonal Initial Pass/Fail: Pass Overall Compliance: No Severity Score: 0

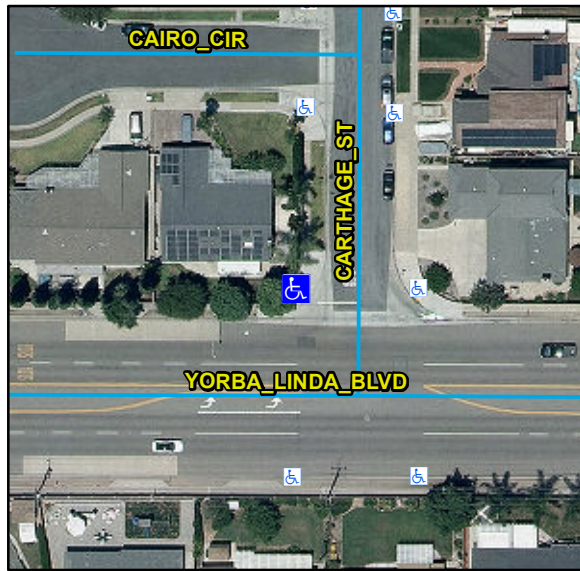
## Field Measurements/Component Compliance

| Compliance | Description | Data | Compliance | Description | Data |
|---|---|---|---|---|---|
| Yes | Gutter Ponding | No | No | Curb Slope | 8.7 |

### Possible Solutions:

Remove & Replace Curb Ramp With Two New Directional Ramps or Equivalent.

R304.2.2, R304.2.1, STD 1115
