# Access Compliance Report Public Rights-of-Way (Curb Ramps)

Main Street: CARTHAGE\_ST Cross Street: YORBA\_LINDA\_BLVD Location: NE

ADA ID: RPAT210917142130 Ramp Type: Type 1 - Perpendicular Diagonal Initial Pass/Fail: Pass Overall Compliance: No Severity Score: 4

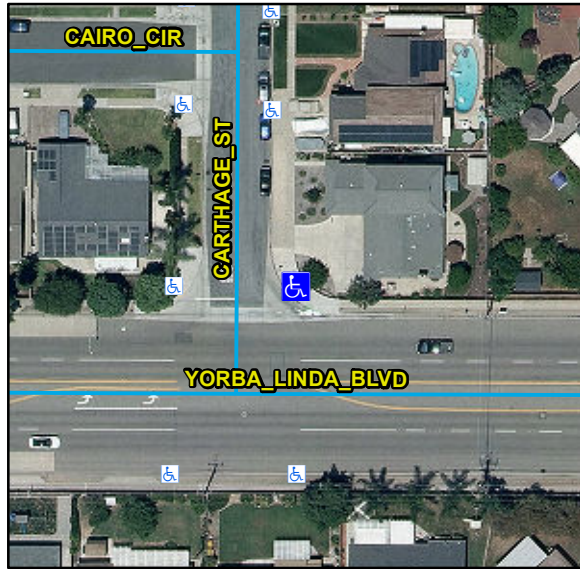
| Compliance | Description | Data | Compliance | Description | Data |
|---|---|---|---|---|---|
| Yes | Gutter Ponding | No | No | Curb Slope | 9.9 |

Remove & Replace Curb Ramp With Two New Directional Ramps or Equivalent.

R304.2.2, R304.2.1, STD 1115
