# Access Compliance Report Public Rights-of-Way (Curb Ramps)

Main Street: YORBA\_LINDA\_BLV Cross Street: KILT\_AVE Location: SE

ADA ID: RPAT210917143427 Ramp Type: Type 1 - Perpendicular Diagonal Initial Pass/Fail: Fail Overall Compliance: No Severity Score: 2

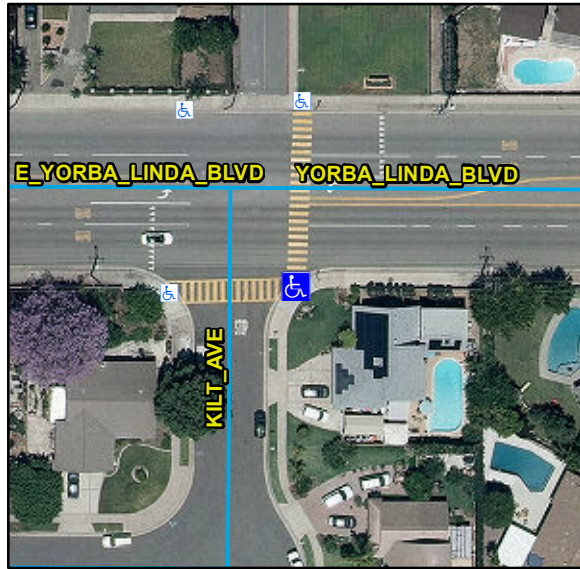
| Compliance | Description | Data | Compliance | Description | Data |
|---|---|---|---|---|---|
| No | Ramp Cross Slope (%) | 4 | N/A | Flare Traversable LT | N/A |
| N/A | Gutter Ponding | N/A | No | Curb Slope | 9.4 |

Remove & Replace Curb Ramp With Two New Directional Ramps or Equivalent.

R304.2.2, R304.5.3, STD 1115
