# Access Compliance Report Public Rights-of-Way (Curb Ramps)

Main Street: KILT\_AVE Cross Street: E\_YORBA\_LINDA\_BLVD Location: SW

ADA ID: RPAT210917144037 Ramp Type: Type 1 - Perpendicular Diagonal Initial Pass/Fail: Pass Overall Compliance: No Severity Score: 7

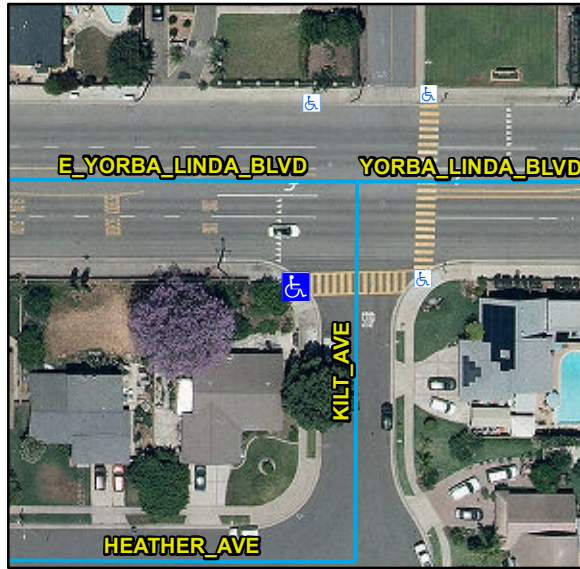
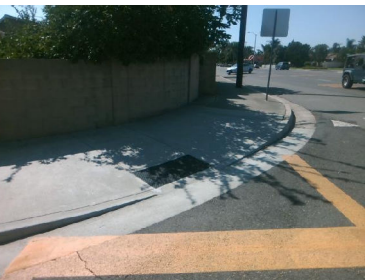
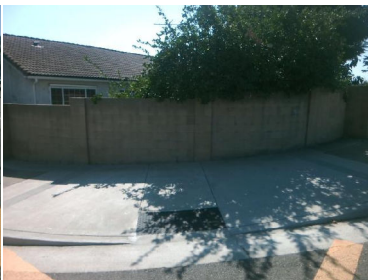
| Compliance | Description | Data | Compliance | Description | Data |
|---|---|---|---|---|---|
| No | Ramp Cross Slope (%) | 4.5 | N/A | Flare Traversable LT | Yes |
| No | Landing Run Slope (%) | 3.1 | N/A | Flare Traversable RT | Yes |
| No | Landing Cross Slope (%) | 5 | Yes | DWS Provided | Yes |
| No | Gutter Run Slope (%) | 5.9 | | Road Cross Slope (%) | 4 |
| No | Gutter Cross Slope (%) | 4.7 | | | |

Remove & Replace Curb Ramp With Two New Directional Ramps or Equivalent. Remove & Replace Gutter.
