# Access Compliance Report Public Rights-of-Way (Curb Ramps)

Main Street: VALENCIA\_AVE Cross Street: CARBON\_CANYON\_RD Location: NE

ADA ID: RPAT210920091957 Ramp Type: Type 1 - Perpendicular Initial Pass/Fail: Pass Overall Compliance: No Severity Score: 0

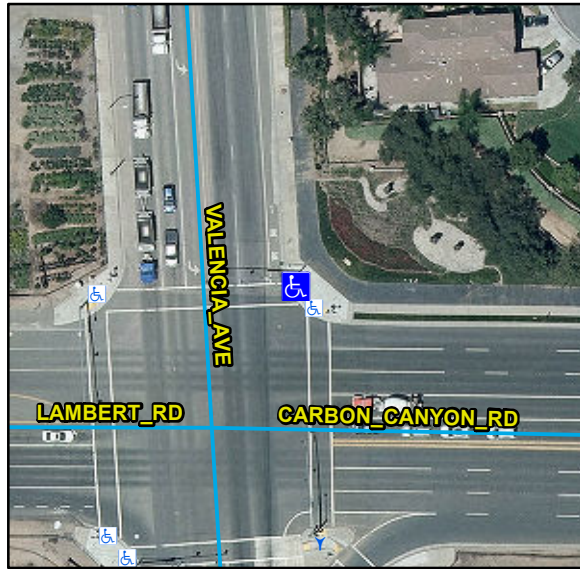
| Compliance | Description | Data | Compliance | Description | Data |
|---|---|---|---|---|---|
| Yes | Obstructions Present? | No | N/A | Utilities Present? | Yes |
| | Obstruction Dimensions | <Null> | | Traffic Signal Pole | |

| Compliance | Description | Data | Compliance | Description | Data |
|---|---|---|---|---|---|
| Yes | Gutter Ponding | No | No | Curb Slope | 8 |

Remove & Replace Curb Slope. Utility Present.

R304.2.2, STD 1115
