# Access Compliance Report Public Rights-of-Way (Curb Ramps)

| Main Street: CARBON_CANYON_RD | | Cross Street: VALENCIA_AVE | | Location: | NE |
| ADA ID: RPAT210920093043 | Ramp Type:Type 1 - Perpendicular | Initial Pass/Fail: Pass | Overall Compliance: No | Severity Score: | 0 |

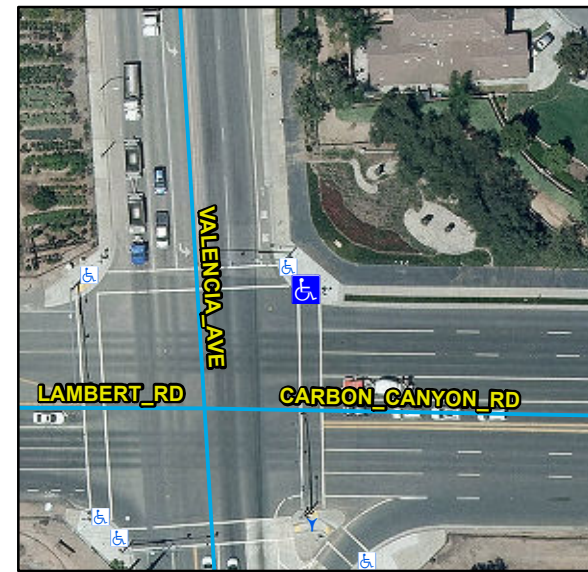
| Compliance | Description | Data | Compliance | Description | Data |
|---|---|---|---|---|---|
| Yes | Gutter Ponding | No | No | Curb Slope | 8.1 |

Remove & Replace Curb Slope. Utility Present.

R304.2.2, STD 1115

Total Cost: \$ 252
