# Access Compliance Report Public Rights-of-Way (Curb Ramps)

| Main Street: LAMBERT_RD | | Cross Street: VALENCIA_AVE | | Location: | SW |
| ADA ID: RPAT210920101415 | Ramp Type:Type 1 - Perpendicular | Initial Pass/Fail: Pass | Overall Compliance: No | Severity Score: | 0 |

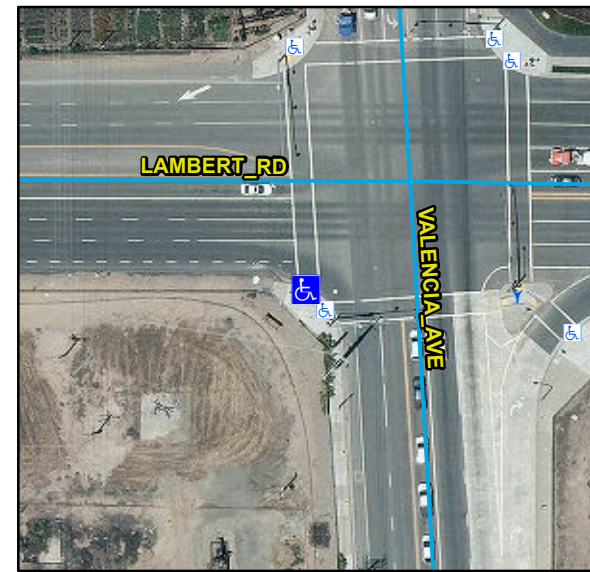
| Compliance | Description | Data | Compliance | Description | Data |
|---|---|---|---|---|---|
| Yes | Gutter Ponding | No | No | Curb Slope | 10.1 |

Possible Solutions:

**Remove & Replace Curb Slope. Utility Present.**

**R304.2.2, STD 1115**
