# Access Compliance Report Public Rights-of-Way (Curb Ramps)

Main Street: VALENCIA\_AVE Cross Street: LAMBERT\_RD Location: SW

ADA ID: RPAT210920102012 Ramp Type: Type 1 - Perpendicular Initial Pass/Fail: Pass Overall Compliance: No Severity Score: 2

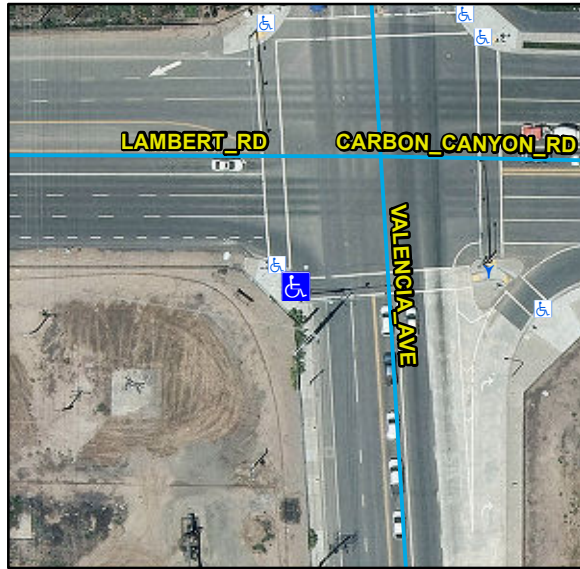
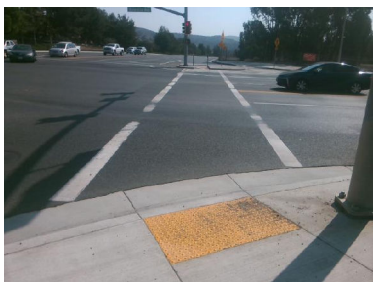
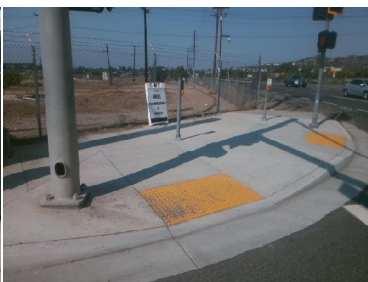
| Compliance | Description | Data | Compliance | Description | Data |
|---|---|---|---|---|---|
| Yes | Gutter Ponding | No | No | Curb Slope | 7.8 |

Remove & Replace Curb Slope. Utility Present.

R304.2.2, STD 1115

Total Cost: \$ 252
