# Access Compliance Report Public Rights-of-Way (Curb Ramps)

| Main Street: CARBON_CANYON_RD | | Cross Street: VALENCIA_AVE | | Location: | SE |
| ADA ID: RPAT210920105215 | Ramp Type:Type 1 - Perpendicular | Initial Pass/Fail: Pass | Overall Compliance: No | Severity Score: | 2 |

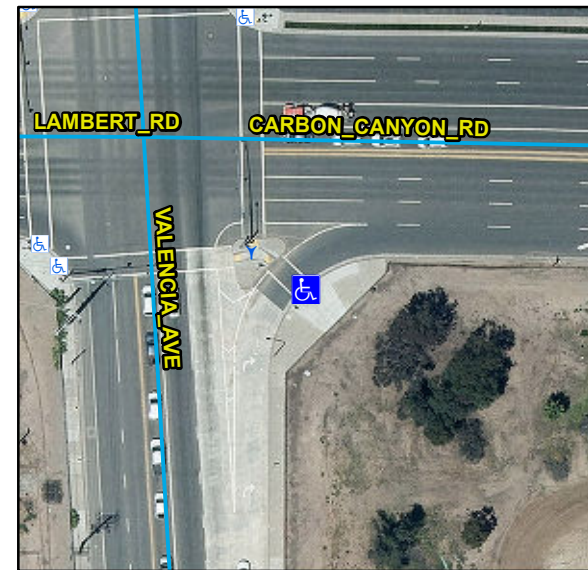
| Compliance | Description | Data | Compliance | Description | Data |
|---|---|---|---|---|---|
| Yes | Gutter Ponding | No | No | Curb Slope | 6.4 |

Possible Solutions:

Remove & Replace Curb Slope.

R304.2.2, STD 1115

Total Cost: \$ 252

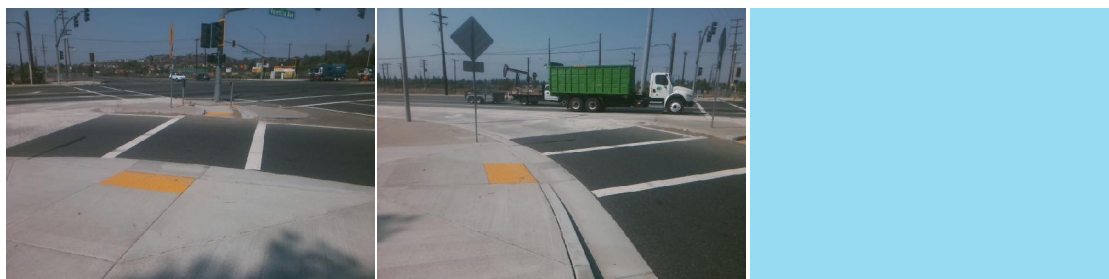
## Obstruction and Utility Measurement/Component Compliance

| Compliance | Description | Data | Compliance | Description | Data |
|---|---|---|---|---|---|
| Yes | Obstructions Present? | No | N/A | Utilities Present? | No |
