# Access Compliance Report Public Rights-of-Way (Curb Ramps)

Main Street: CARBON\_CANYON\_RD Cross Street: SANTA\_FE\_AVE Location: SE

ADA ID: RPAT210920125721 Ramp Type: Type 1 - Perpendicular Initial Pass/Fail: Pass Overall Compliance: No Severity Score: 0

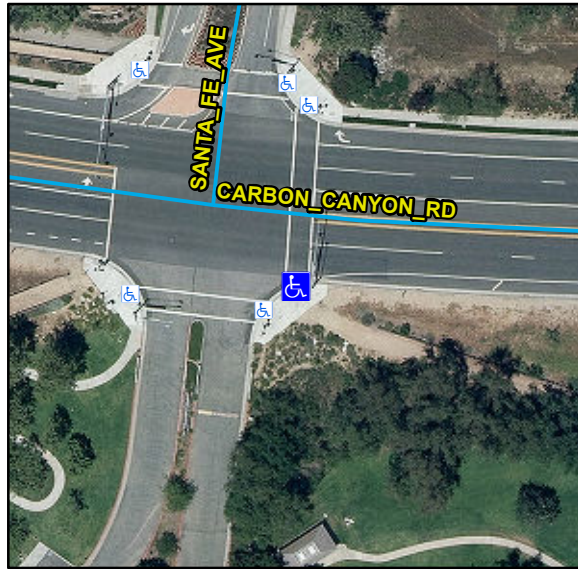
Remove & Replace Curb Slope. Utility Present.

| Compliance | Description | Data | Compliance | Description | Data |
|---|---|---|---|---|---|
| Yes | Gutter Ponding | No | No | Curb Slope | 11.2 |
