Access Compliance Report Public Rights-of-Way (Curb Ramps)

Main Street: N/A Cross Street: CARBON_CANYON_RD Location: SW

ADA ID: RPAT210920131338 Ramp Type: Type 1 - Perpendicular Initial Pass/Fail: Pass Overall Compliance: No Severity Score: 0

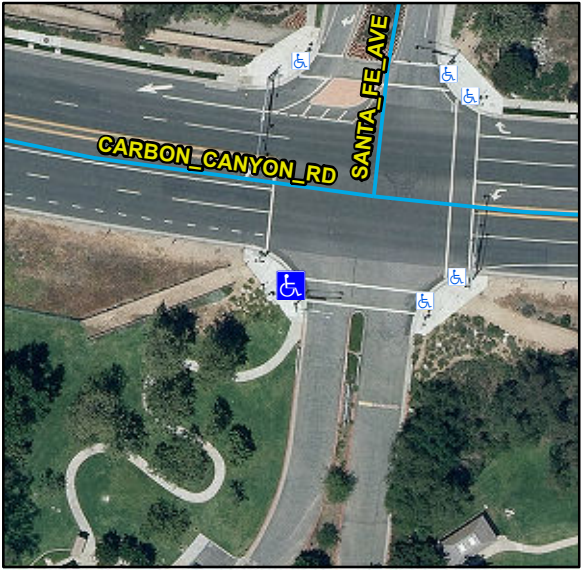
Compliance	Description	Data	Compliance	Description	Data
N/A	Ramp Length (in)	95	N/A	Flare Type LT	
Yes	Ramp Width (in)	60			Sloped
Yes	Ramp Run Slope (%)	6.7	N/A	Flare Slope LT (%)	5.5
Yes	Ramp Cross Slope (%)	1.6	N/A	Flare Traversable LT	No
N/A	Landing Present	Yes	N/A	Flare Type RT	
N/A	Landing Length (in)	61			Sloped
Yes	Landing Width (in)	60	Yes	Flare Slope RT (%)	8.1
Yes	Landing Run Slope (%)	1	N/A	Flare Traversable RT	Yes
Yes	Landing Cross Slope (%)	1.8	Yes	DWS Provided	Yes
N/A	Landing Movement Obstructed?	Yes	Yes	DWS Contrast	Yes
	Landing Movement Type	Control Box	Yes	DWS Length (in)	36
N/A	Landing Shared	No	Yes	DWS Full Width	Yes
N/A	Clear Space	N/A	Yes	DWS Offset Left (in)	0
N/A	Clear Space To Crosswalk (in)	N/A	Yes	DWS Offset Right (in)	N/A
N/A	Marked Crosswalk 1	Yes	N/A	Marked Crosswalk 2	N/A
	Crossing 1 Direction	E		Crossing 2 Direction	N/A
	Marked Crosswalk 1 Width (in)	120		Marked Crosswalk 2 Width (in)	N/A

Yes	Ramp Inside Crosswalk 1	Yes	Yes	Ramp Inside Crosswalk 2	N/A
	Crossing 1 Slope (%)	1.7		Crossing 2 Slope (%)	N/A
	Crossing 1 Cross Slope (%)	3.3		Crossing 2 Cross Slope (%)	N/A
Yes	Gutter Ponding	No	No	Curb Slope	6.1
Yes	Gutter Lip Height (in)	0		Road Run Slope (%)	N/A
Yes	Gutter Run Slope (%)	1.1		Road Cross Slope (%)	N/A
Yes	Gutter Cross Slope (%)	1.1			
Yes	Overall Surface Condition:	Acceptable	Yes	Perp Joint Present	Yes
	Cross Gutter Present?	No		Spandrel Present?	No
	Replace Cross Gutter?	N/A		Replace Spandrel?	N/A

Possible Solutions:
Remove & Replace Curb Slope.

OC Std/PROW:
R304.2.2, STD 1115
