# Access Compliance Report Public Rights-of-Way (Curb Ramps)

Main Street: N/A Cross Street: CARBON\_CANYON\_RD Location: NE

ADA ID: RPAT210920132434 Ramp Type: Type 1 - Perpendicular Initial Pass/Fail: Pass Overall Compliance: Yes Severity Score: 0

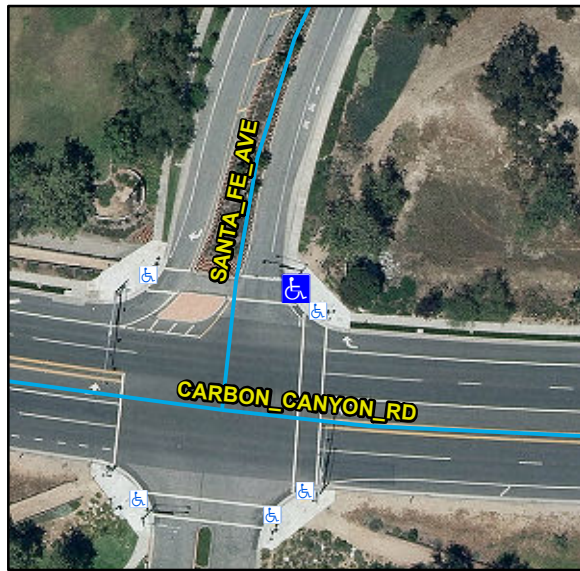
Utility Present.

| Compliance | Description | Data | Compliance | Description | Data |
|---|---|---|---|---|---|
| Yes | Obstructions Present? | No | N/A | Utilities Present? | Yes |
| | Obstruction Dimensions | N/A | | Traffic Signal Pole | |
