# Access Compliance Report Public Rights-of-Way (Curb Ramps)

Main Street: **CARBON\_CANYON\_RD** Cross Street: **N/A** Location: **NE**

ADA ID: **RPAT210920132926** Ramp Type: **Type 1 - Perpendicular** Initial Pass/Fail: **Pass** Overall Compliance: **No** Severity Score: **0**

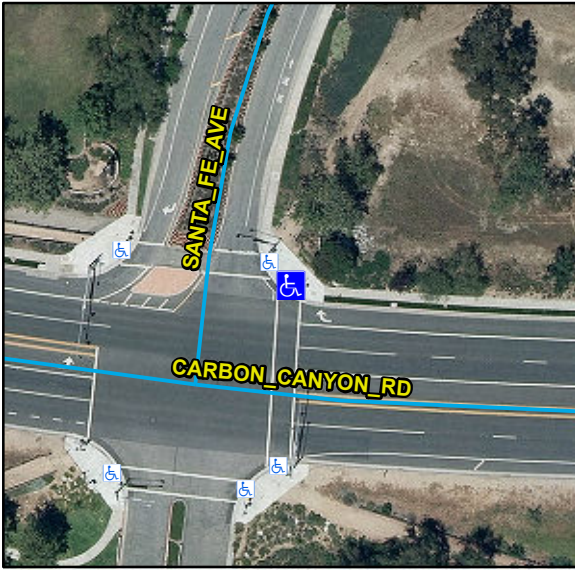
Compliance	Description	Data	Compliance	Description	Data
<b>N/A</b>	Ramp Length (in)	<b>105</b>	<b>N/A</b>	Flare Type LT	
<b>Yes</b>	Ramp Width (in)	<b>60</b>		Flare Slope LT (%)	<b>9</b>
<b>Yes</b>	Ramp Run Slope (%)	<b>7.3</b>	<b>Yes</b>	Flare Traversable LT	<b>Yes</b>
<b>Yes</b>	Ramp Cross Slope (%)	<b>0.2</b>	<b>N/A</b>	Flare Type RT	
<b>N/A</b>	Landing Present	<b>Yes</b>		Flare Slope RT (%)	<b>7</b>
<b>N/A</b>	Landing Length (in)	<b>65</b>		Flare Traversable RT	<b>No</b>
<b>Yes</b>	Landing Width (in)	<b>60</b>	<b>N/A</b>	DWS Provided	<b>Yes</b>
<b>Yes</b>	Landing Run Slope (%)	<b>2</b>	<b>N/A</b>	DWS Contrast	<b>Yes</b>
<b>Yes</b>	Landing Cross Slope (%)	<b>1.1</b>	<b>Yes</b>	DWS Length (in)	<b>36</b>
<b>N/A</b>	Landing Movement Obstructed?	<b>No</b>	<b>Yes</b>	DWS Full Width	<b>Yes</b>
	Landing Movement Type	<b>N/A</b>	<b>Yes</b>	DWS Offset Left (in)	<b>0</b>
<b>N/A</b>	Landing Shared	<b>No</b>	<b>Yes</b>	DWS Offset Right (in)	<b>N/A</b>

Possible Solutions:  
**Remove & Replace Curb Slope. Utility Present.**

OC Std/PROW:  
**R304.2.2, STD 1115**
