# Access Compliance Report Public Rights-of-Way (Curb Ramps)

Main Street: N/A Cross Street: CARBON\_CANYON\_RD Location: NW

ADA ID: RPAT210920133533 Ramp Type: Type 1 - Perpendicular Initial Pass/Fail: Pass Overall Compliance: No Severity Score: 0

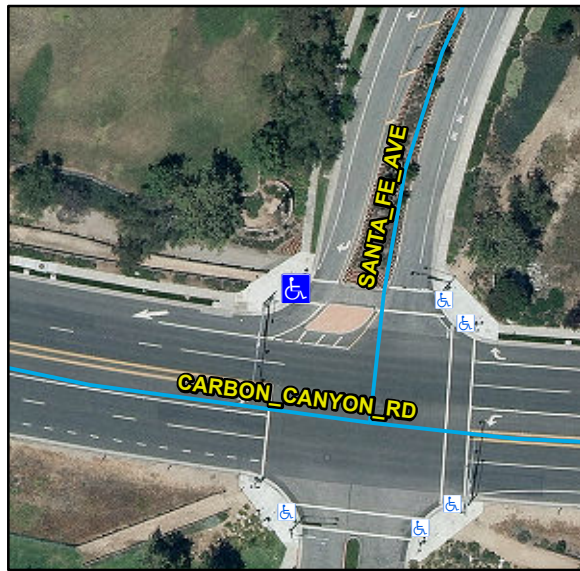
| Compliance | Description | Data | Compliance | Description | Data |
|---|---|---|---|---|---|
| Yes | Obstructions Present? | No | N/A | Utilities Present? | Yes |

| Compliance | Description | Data | Compliance | Description | Data |
|---|---|---|---|---|---|
| Yes | Gutter Ponding | No | No | Curb Slope | 6.5 |

Remove & Replace Curb Slope. Utility Present.

R304.2.2, STD 1115

Total Cost: \$ 252
