# Access Compliance Report Public Rights-of-Way (Curb Ramps)

| Main Street: BREA_HILLS_AVE | | Cross Street: CARBON_CANYON_RD | | Location: | NW |
| ADA ID: RPAT210920134900 | Ramp Type:Type 1 - Perpendicular | Initial Pass/Fail: Fail | Overall Compliance: No | Severity Score: | 16 |

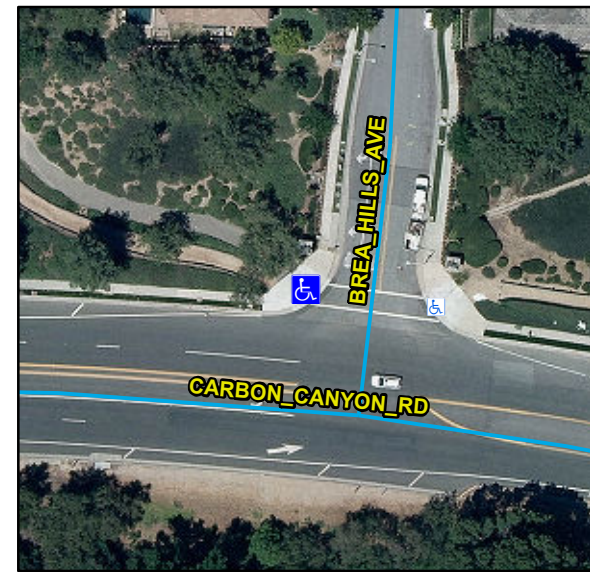
R304.2.2, STD 1115

| Compliance | Description | Data | Compliance | Description | Data |
|---|---|---|---|---|---|
| No | Ramp Run Slope (%) | 9.1 | N/A | Flare Slope LT (%) | N/A |

Remove & Replace Entire Ramp.

Total Cost: \$ 3080
