# Access Compliance Report Public Rights-of-Way (Curb Ramps)

| Main Street: N/A | | Cross Street: CARBON_CANYON_RD | | Location: | NE |
| ADA ID: RPAT210920135159 | Ramp Type:Type 1 - Perpendicular | Initial Pass/Fail: Pass | Overall Compliance: No | Severity Score: | 0 |

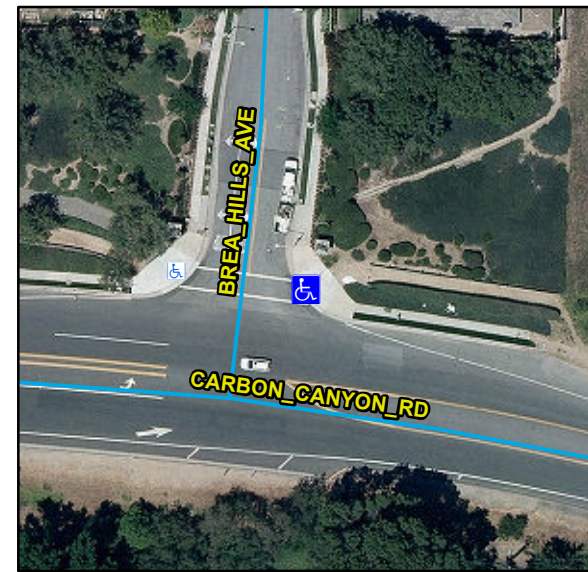
| Compliance | Description | Data | Compliance | Description | Data |
|---|---|---|---|---|---|
| Yes | Gutter Ponding | No | No | Curb Slope | 8.1 |

Possible Solutions:

Remove & Replace Curb Slope.

R304.2.2, STD 1115

Total Cost: \$ 252
