# Access Compliance Report Public Rights-of-Way (Curb Ramps)

Main Street: ANDORA\_DR Cross Street: FAIRHOPE\_DR Location: N

ADA ID: RPAT210921082007 Ramp Type: Type 4 - Parallel Initial Pass/Fail: Pass Overall Compliance: No Severity Score: 9

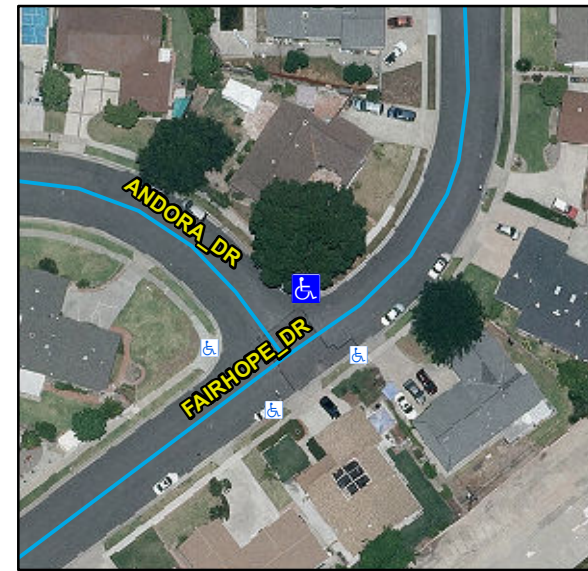
| Compliance | Description | Data | Compliance | Description | Data |
|---|---|---|---|---|---|
| No | Landing Width (in) | 46 | Yes | DWS Length (in) | 38 |
| No | Gutter Run Slope (%) | 10.2 | | Road Cross Slope (%) | 5.1 |

Remove & Replace Landing. Remove & Replace Gutter.

R304.2.1, R304.5.4, STD 1115
