# Access Compliance Report Public Rights-of-Way (Curb Ramps)

Main Street: FAIRHOPE\_DR Cross Street: ANDORA\_DR Location: NW

ADA ID: RPAT210921082833 Ramp Type: Type 4 - Parallel Initial Pass/Fail: Fail Overall Compliance: No Severity Score: 15

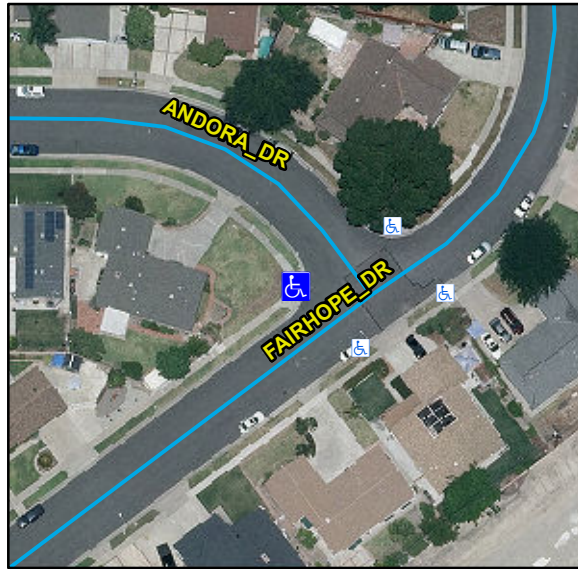
| Compliance | Description | Data | Compliance | Description | Data |
|---|---|---|---|---|---|
| Yes | Ramp Run Slope LT (%) | 6.9 | No | Ramp Run Slope RT (%) | 10.1 |
| No | Gutter Lip Height (in) | 1 | | Road Run Slope (%) | 1.4 |

**Remove & Replace Curb Ramp With Two New Directional Ramps or Equivalent. Grind Gutter Lip.**

**R304.3.2, R302.7.2, STD 1115**
