# Access Compliance Report Public Rights-of-Way (Curb Ramps)

Main Street: BARRINGTON\_DR Cross Street: FAIRHOPE\_DR Location: NE

ADA ID: RPAT210921083634 Ramp Type: Type 4 - Parallel Initial Pass/Fail: Pass Overall Compliance: No Severity Score: 2

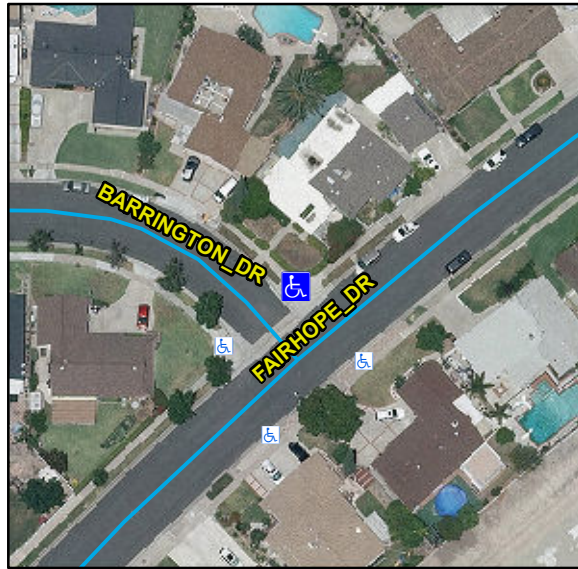
| Compliance | Description | Data | Compliance | Description | Data |
|---|---|---|---|---|---|
| Yes | Ramp Cross Slope LT (%) | 0.9 | No | Ramp Cross Slope RT (%) | 2.6 |

Remove & Replace Curb Ramp With Two New Directional Ramps or Equivalent.

R304.5.3, STD 1115
