# Access Compliance Report Public Rights-of-Way (Curb Ramps)

| Main Street: FAIRHOPE_DR | | Cross Street: BARRINGTON_DR | | Location: | NW |
| ADA ID: RPAT210921084158 | Ramp Type: Type 4 - Parallel | Initial Pass/Fail: Fail | Overall Compliance: No | Severity Score: | 15 |

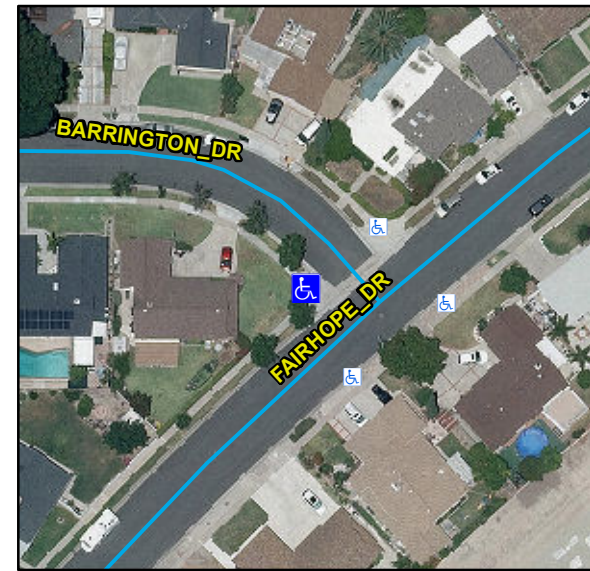
| Compliance | Description | Data | Compliance | Description | Data |
|---|---|---|---|---|---|
| Yes | Ramp Run Slope LT (%) | 1.5 | No | Ramp Run Slope RT (%) | 8.6 |

**Remove & Replace Curb Ramp With Two New Directional Ramps or Equivalent.**

**R304.3.2, STD 1115**

Total Cost: \$ 4000
