# Access Compliance Report Public Rights-of-Way (Curb Ramps)

Main Street: N/A Cross Street: FAIRHOPE\_DR Location: NE

ADA ID: RPAT210921084807 Ramp Type: Type 4 - Parallel Initial Pass/Fail: Pass Overall Compliance: Yes Severity Score: 0

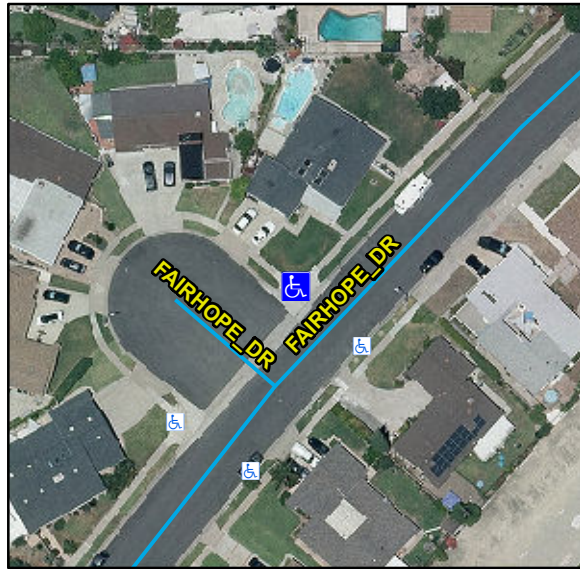
| Compliance | Description | Data | Compliance | Description | Data |
|---|---|---|---|---|---|
| N/A | Ramp Length LT (in) | 57 | N/A | Ramp Length RT (in) | 89 |
| Yes | Ramp Width LT (in) | 114 | Yes | Ramp Width RT (in) | 113 |
| Yes | Ramp Run Slope LT (%) | 6.1 | Yes | Ramp Run Slope RT (%) | 5.4 |
| Yes | Ramp Cross Slope LT (%) | 1.3 | Yes | Ramp Cross Slope RT (%) | 0.9 |
| Yes | Overall Surface Condition | Acceptable | | | |

Possible Solutions:

N/A
