# Access Compliance Report Public Rights-of-Way (Curb Ramps)

Main Street: FAIRHOPE\_DR Cross Street: N/A Location: SW

ADA ID: RPAT210921085412 Ramp Type: Type 4 - Parallel Initial Pass/Fail: Fail Overall Compliance: No Severity Score: 15

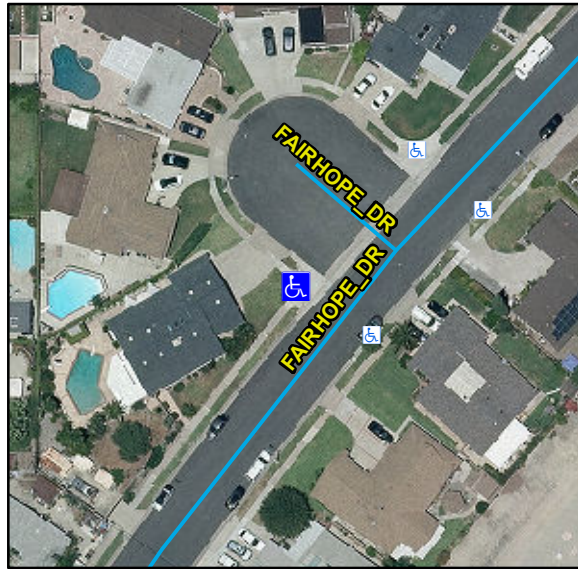
| Compliance | Description | Data | Compliance | Description | Data |
|---|---|---|---|---|---|
| Yes | Ramp Run Slope LT (%) | 5.8 | No | Ramp Run Slope RT (%) | 9.2 |

Remove & Replace Curb Ramp With Two New Directional Ramps or Equivalent.

R304.3.2, STD 1115
