# Access Compliance Report Public Rights-of-Way (Curb Ramps)

| Main Street: DELAFIELD_DR | | Cross Street: FAIRHOPE_DR | | Location: | N |
| ADA ID: RPAT210921091344 | Ramp Type: Type 4 - Parallel | Initial Pass/Fail: Fail | Overall Compliance: No | Severity Score: | 15 |

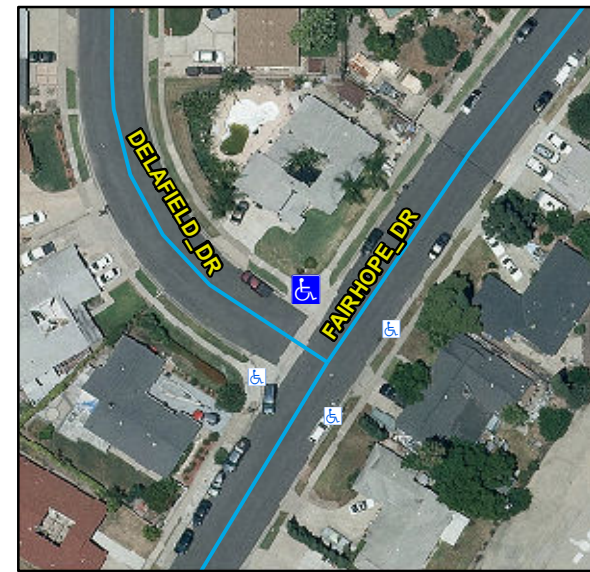
| Compliance | Description | Data | Compliance | Description | Data |
|---|---|---|---|---|---|
| Yes | Ramp Run Slope LT (%) | 6.4 | No | Ramp Run Slope RT (%) | 8.4 |

**Remove & Replace Curb Ramp With Two New Directional Ramps or Equivalent.**

**R304.3.2, STD 1115**

Total Cost: \$ 4000

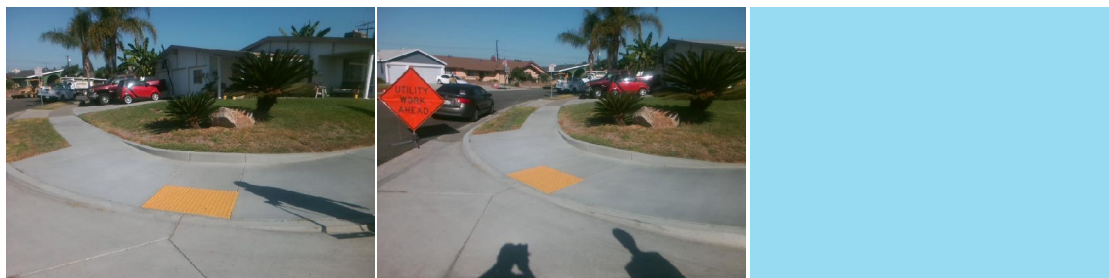
| Compliance | Description | Data | Compliance | Description | Data |
|---|---|---|---|---|---|
| N/A | Ramp Length LT (in) | 100 | N/A | Ramp Length RT (in) | 100 |
| Yes | Ramp Width LT (in) | 97 | Yes | Ramp Width RT (in) | 100 |
| Yes | Ramp Cross Slope LT (%) | 0.3 | Yes | Ramp Cross Slope RT (%) | 1.8 |
