# Access Compliance Report Public Rights-of-Way (Curb Ramps)

Main Street: FAIRHOPE\_DR Cross Street: DELAFIELD\_DR Location: NW

ADA ID: RPAT210921091754 Ramp Type: Type 4 - Parallel Initial Pass/Fail: Fail Overall Compliance: No Severity Score: 16

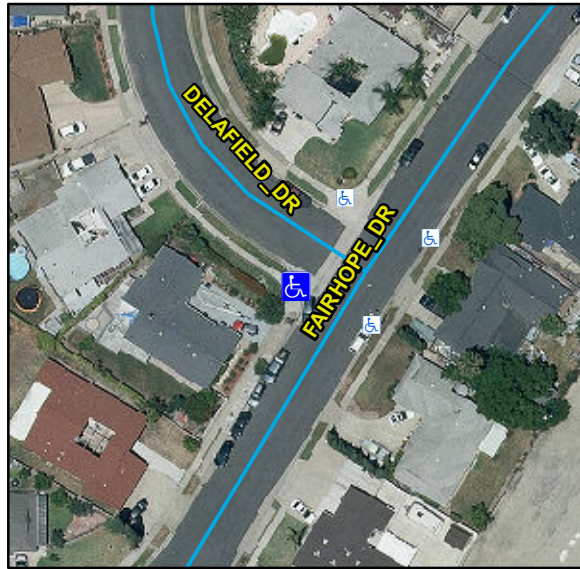
| Compliance | Description | Data | Compliance | Description | Data |
|---|---|---|---|---|---|
| Yes | Ramp Run Slope LT (%) | 6.6 | No | Ramp Run Slope RT (%) | 10.2 |
| No | Ramp Cross Slope LT (%) | 2.7 | Yes | Ramp Cross Slope RT (%) | 1.6 |
| No | Gutter Lip Height (in) | 1 | | Road Run Slope (%) | 0.6 |

**Remove & Replace Curb Ramp With Two New Directional Ramps or Equivalent. Grind Gutter Lip.**

**R304.5.3, R304.3.2, R302.7.2, STD 1115**
