# Access Compliance Report Public Rights-of-Way (Curb Ramps)

| Main Street: ANDORA_DR | | Cross Street: MERCADO_AVE | | Location: | NW |
| ADA ID: RPAT210921092948 | Ramp Type: Type 4 - Parallel | Initial Pass/Fail: Fail | Overall Compliance: No | Severity Score: | 16 |

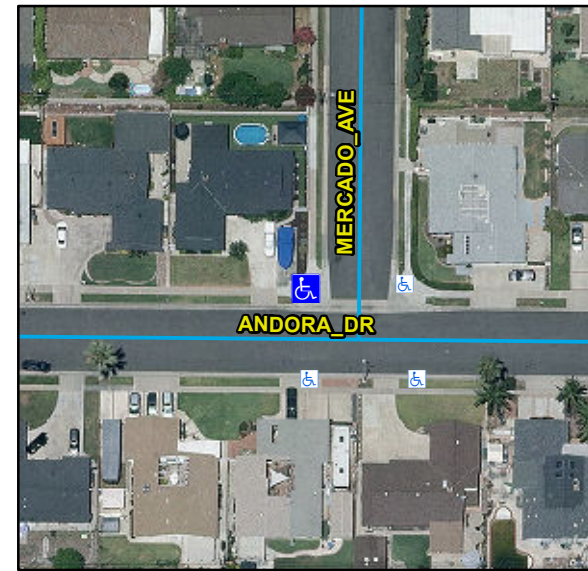
| Compliance | Description | Data | Compliance | Description | Data |
|---|---|---|---|---|---|
| Yes | Ramp Run Slope LT (%) | 6.4 | No | Ramp Run Slope RT (%) | 11.8 |
| No | Ramp Cross Slope LT (%) | 2.6 | Yes | Ramp Cross Slope RT (%) | 0.5 |

**Remove & Replace Curb Ramp With Two New Directional Ramps or Equivalent.**

**R304.5.3, R304.3.2, STD 1115**

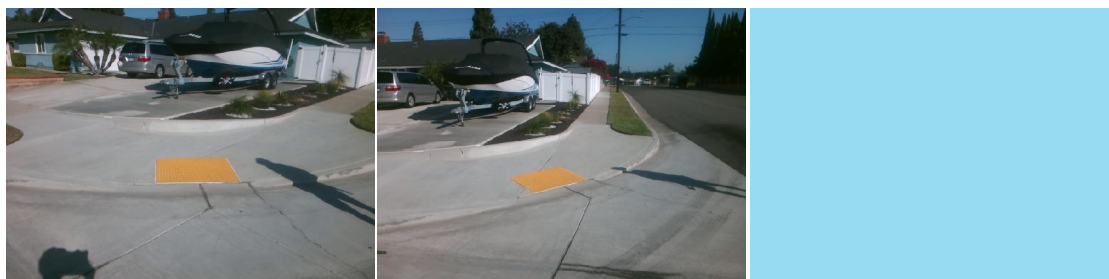
| Compliance | Description | Data | Compliance | Description | Data |
|---|---|---|---|---|---|
| Yes | Obstructions Present? | No | N/A | Utilities Present? | No |
