# Access Compliance Report Public Rights-of-Way (Curb Ramps)

| Main Street: MERCADO_AVE | | Cross Street: ANDORA_DR | | Location: | NE |
| ADA ID: RPAT210921093352 | Ramp Type: Type 4 - Parallel | Initial Pass/Fail: Fail | Overall Compliance: No | Severity Score: | 15 |

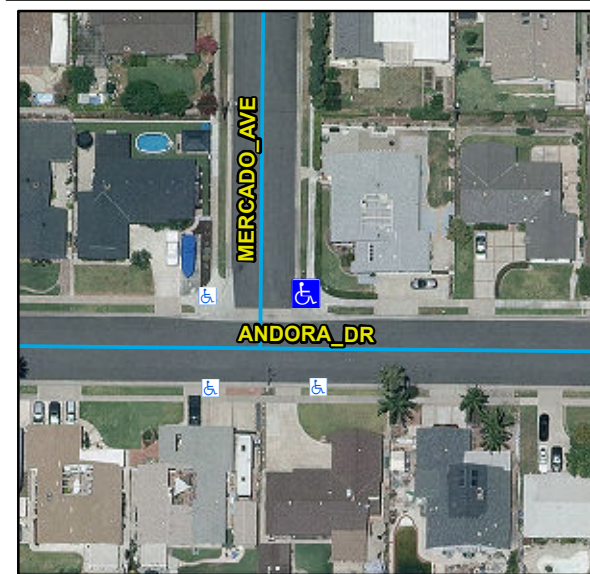
| Compliance | Description | Data | Compliance | Description | Data |
|---|---|---|---|---|---|
| Yes | Ramp Run Slope LT (%) | 6.9 | No | Ramp Run Slope RT (%) | 9.5 |

**Remove & Replace Curb Ramp With Two New Directional Ramps or Equivalent.**

**R304.3.2, STD 1115**

Total Cost: \$ 4000
