# Access Compliance Report Public Rights-of-Way (Curb Ramps)

Main Street: ASHGROVE\_DR Cross Street: MERCADO\_AVE Location: SE

ADA ID: RPAT210921100046 Ramp Type: Type 4 - Parallel Initial Pass/Fail: Fail Overall Compliance: No Severity Score: 32

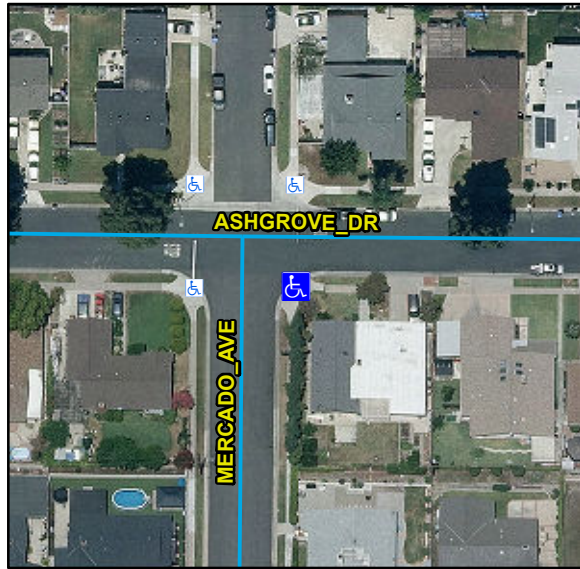
| Compliance | Description | Data | Compliance | Description | Data |
|---|---|---|---|---|---|
| No | Ramp Run Slope LT (%) | 12.1 | Yes | Ramp Run Slope RT (%) | 4.1 |
| No | Ramp Cross Slope LT (%) | 3.2 | No | Ramp Cross Slope RT (%) | 4.5 |

**Remove & Replace Curb Ramp With Two New Directional Ramps or Equivalent.**

**R304.3.2, R304.5.3, STD 1115**
