# Access Compliance Report Public Rights-of-Way (Curb Ramps)

| Main Street: MERCADO_AVE | | Cross Street: ASHGROVE_DR | | Location: | SW |
| ADA ID: RPAT210921101927 | Ramp Type: Type 4 - Parallel | Initial Pass/Fail: Fail | Overall Compliance: No | Severity Score: | 16 |

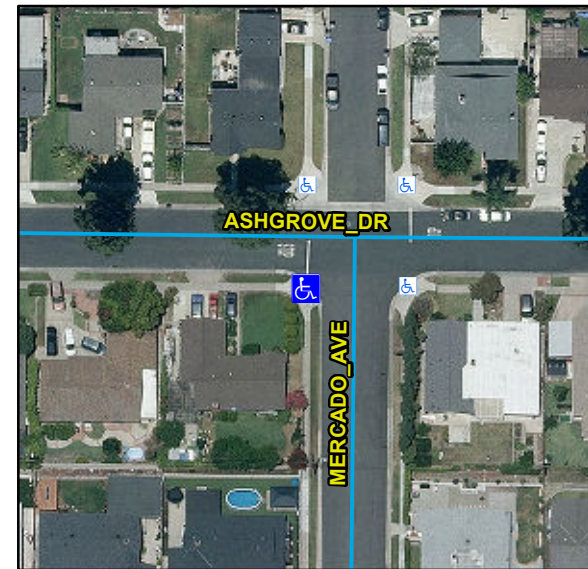
| Compliance | Description | Data | Compliance | Description | Data |
|---|---|---|---|---|---|
| Yes | Ramp Run Slope LT (%) | 3.5 | No | Ramp Run Slope RT (%) | 9.8 |
| No | Ramp Cross Slope LT (%) | 3.6 | Yes | Ramp Cross Slope RT (%) | 1.9 |
| No | Gutter Lip Height (in) | 1 | | Road Run Slope (%) | 1.2 |

**Remove & Replace Curb Ramp With Two New Directional Ramps or Equivalent. Grind Gutter Lip.**

**R304.5.3, R304.3.2, R302.7.2, STD 1115**

Total Cost: \$ 4150

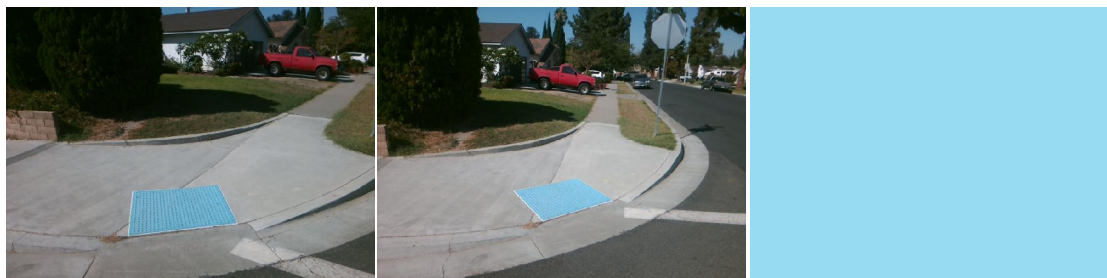
| Compliance | Description | Data | Compliance | Description | Data |
|---|---|---|---|---|---|
| Yes | Obstructions Present? | No | N/A | Utilities Present? | No |
| | Obstruction Types | N/A | | Utility Types | |
| | Obstruction Dimensions | N/A | | | N/A |
