Access Compliance Report Public Rights-of-Way (Curb Ramps)

Main Street: **STANTON_AVE** Cross Street: **ASHGROVE_DR** Location: **NE**

ADA ID: **RPAT210921102931** Ramp Type: **Type 1 - Perpendicular Diagonal** Initial Pass/Fail: **Pass** Overall Compliance: **No** Severity Score: **22**

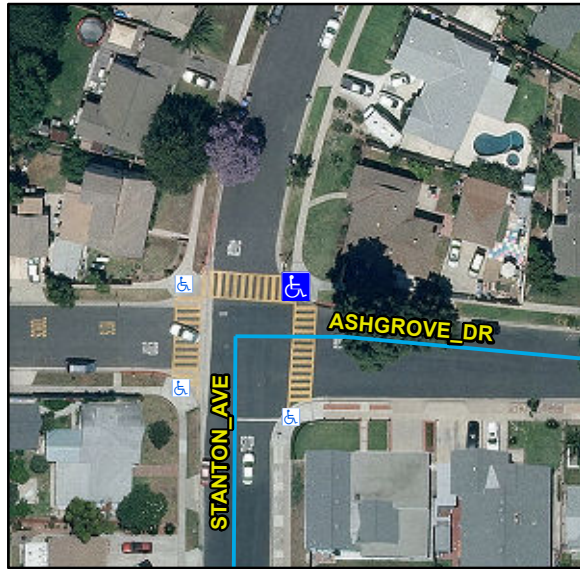
Compliance	Description	Data	Compliance	Description	Data
N/A	Ramp Length (in)	97	N/A	Flare Type LT	
Yes	Ramp Width (in)	48		Flare Slope LT (%)	14.8
Yes	Ramp Run Slope (%)	8	No	Flare Traversable LT	Yes
Yes	Ramp Cross Slope (%)	1.4	N/A	Flare Type RT	
N/A	Landing Present	Yes		Flare Slope RT (%)	5.1
N/A	Landing Length (in)	34		Flare Traversable RT	No
Yes	Landing Width (in)	67	N/A	DWS Provided	Yes
Yes	Landing Run Slope (%)	1	Yes	DWS Contrast	Yes
No	Landing Cross Slope (%)	2.6	Yes	DWS Length (in)	36
N/A	Landing Movement Obstructed?	Yes	Yes	DWS Full Width	Yes
	Landing Movement Type	Curb	Yes	DWS Offset Left (in)	0
N/A	Landing Shared	No	Yes	DWS Offset Right (in)	N/A
Yes	Clear Space	Yes	N/A	Marked Crosswalk 2	Yes
Yes	Clear Space To Crosswalk (in)	48		Crossing 1 Direction	W
N/A	Marked Crosswalk 1	Yes		Crossing 2 Direction	S
	Crossing 1 Width (in)	167		Marked Crosswalk 2 Width (in)	167
Yes	Ramp Inside Crosswalk 1	Yes	Yes	Ramp Inside Crosswalk 2	Yes

Crossing 1 Slope (%)	7.1		Crossing 2 Slope (%)	4.6
	Crossing 1 Cross Slope (%)	1.9		Crossing 2 Cross Slope (%)	4.4
Yes	Gutter Ponding	No	Yes	Curb Slope	1.6
No	Gutter Lip Height (in)	2		Road Run Slope (%)	2.7
Yes	Gutter Run Slope (%)	4		Road Cross Slope (%)	9.2
Yes	Gutter Cross Slope (%)	1.6			
Yes	Overall Surface Condition: Acceptable		Yes	Perp Joint Present	Yes
	Cross Gutter Present?	No		Spandrel Present?	No
	Replace Cross Gutter?	N/A		Replace Spandrel?	N/A

Remove & Replace Curb Ramp With Two New Directional Ramps or Equivalent. Grind Gutter Lip.

R304.2.1, R304.5.3, R304.2.3, R302.7.2, STD 1115
