# Access Compliance Report Public Rights-of-Way (Curb Ramps)

Main Street: ASHGROVE\_DR Cross Street: STANTON\_AVE Location: NW

ADA ID: RPAT210921103632 Ramp Type: Type 1 - Perpendicular Diagonal Initial Pass/Fail: Fail Overall Compliance: No Severity Score: 16

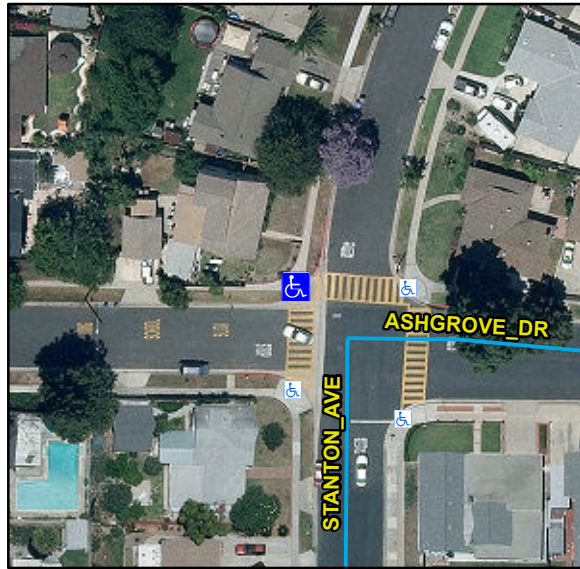
| Compliance | Description | Data | Compliance | Description | Data |
|---|---|---|---|---|---|
| No | Ramp Run Slope (%) | 8.7 | N/A | Flare Slope LT (%) | N/A |
| No | Ramp Cross Slope (%) | 3.1 | N/A | Flare Traversable LT | N/A |

Remove & Replace Curb Ramp With Two New Directional Ramps or Equivalent.
