# Access Compliance Report Public Rights-of-Way (Curb Ramps)

Main Street: ASHGROVE\_DR Cross Street: STANTON\_AVE Location: SE

ADA ID: RPAT210921120448 Ramp Type: Type 4 - Parallel Initial Pass/Fail: Fail Overall Compliance: No Severity Score: 16

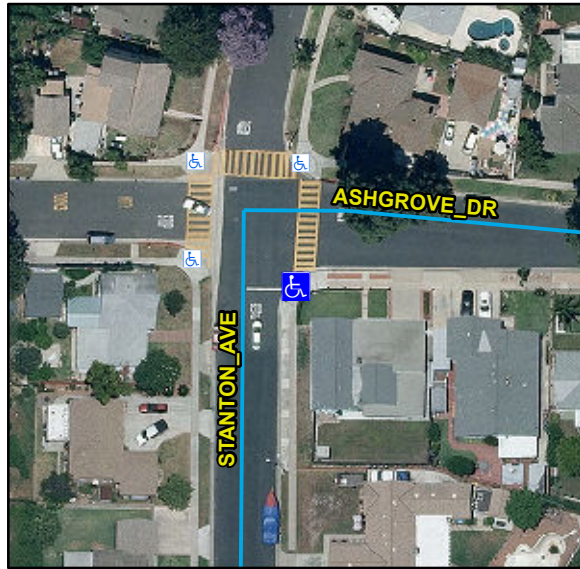
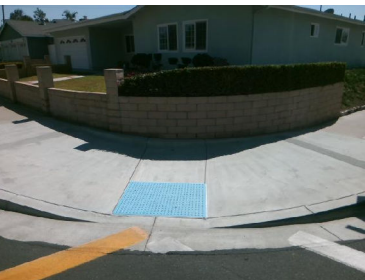
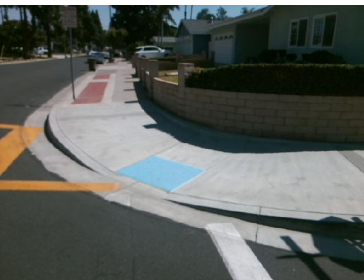
| Compliance | Description | Data | Compliance | Description | Data |
|---|---|---|---|---|---|
| No | Ramp Run Slope LT (%) | 9.7 | Yes | Ramp Run Slope RT (%) | 5.6 |
| Yes | Ramp Cross Slope LT (%) | 0.5 | No | Ramp Cross Slope RT (%) | 2.8 |

Remove & Replace Curb Ramp With Two New Directional Ramps or Equivalent.

R304.3.2, R304.5.3, STD 1115
