# Access Compliance Report Public Rights-of-Way (Curb Ramps)

Main Street: STANTON\_AVE Cross Street: ASHGROVE\_DR Location: SW

ADA ID: RPAT210921121200 Ramp Type: Type 1 - Perpendicular Diagonal Initial Pass/Fail: Fail Overall Compliance: No Severity Score: 15

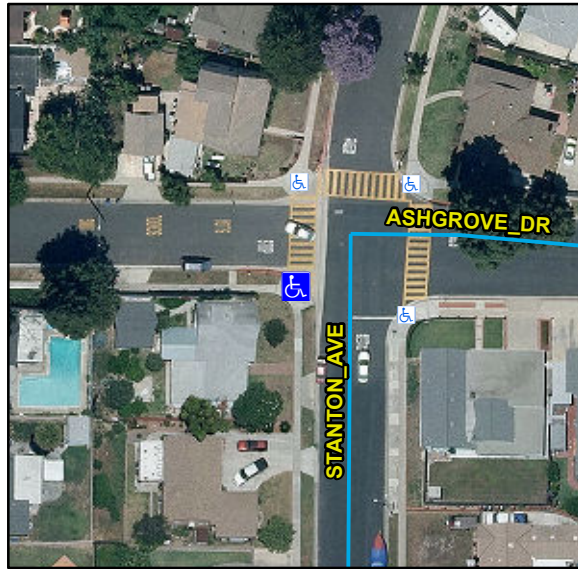
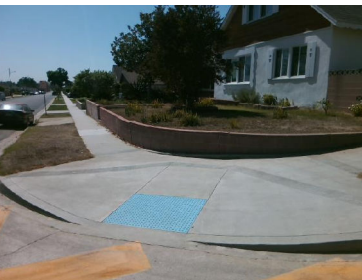
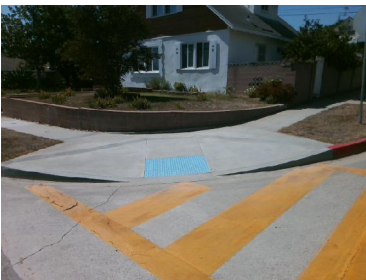
| Compliance | Description | Data | Compliance | Description | Data |
|---|---|---|---|---|---|
| No | Ramp Cross Slope (%) | 5.6 | N/A | Flare Traversable LT | N/A |

**Remove & Replace Curb Ramp With Two New Directional Ramps or Equivalent.**

**R304.2.2, R304.5.3, STD 1115**
