# Access Compliance Report Public Rights-of-Way (Curb Ramps)

Main Street: STANBROOK\_DR Cross Street: STANTON\_AVE Location: NW

ADA ID: RPAT210921122031 Ramp Type: Type 1 - Perpendicular Diagonal Initial Pass/Fail: Fail Overall Compliance: No Severity Score: 4

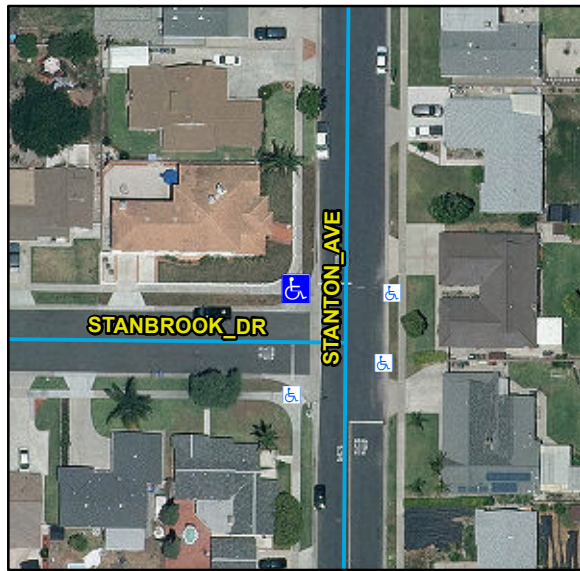
| Compliance | Description | Data | Compliance | Description | Data |
|---|---|---|---|---|---|
| No | Ramp Width (in) | 47 | | | N/A |

Remove & Replace Curb Ramp With Two New Directional Ramps or Equivalent.

R304.2.2, R304.5.1, STD 1115
