# Access Compliance Report Public Rights-of-Way (Curb Ramps)

Main Street: STANTON\_AVE Cross Street: STANBROOK\_DR Location: SW

ADA ID: RPAT210921122337 Ramp Type: Type 1 - Perpendicular Diagonal Initial Pass/Fail: Fail Overall Compliance: No Severity Score: 15

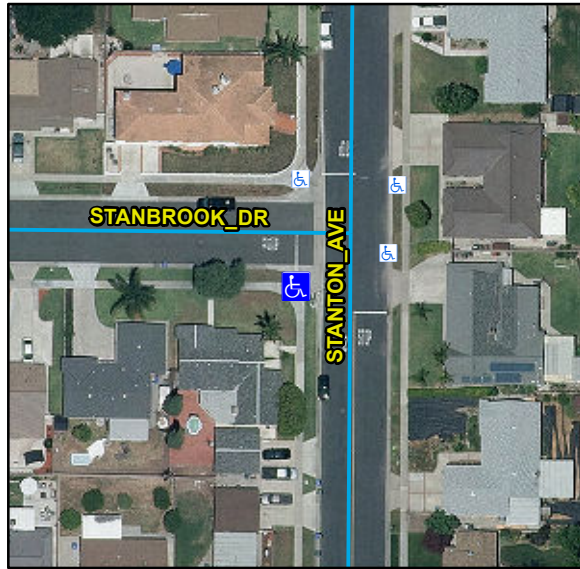
| Compliance | Description | Data | Compliance | Description | Data |
|---|---|---|---|---|---|
| No | Ramp Run Slope (%) | 8.9 | N/A | Flare Slope LT (%) | N/A |

**Remove & Replace Curb Ramp With Two New Directional Ramps or Equivalent.**

**R304.2.2, STD 1115**
