# Access Compliance Report Public Rights-of-Way (Curb Ramps)

Main Street: FAIRHOPE\_DR Cross Street: STANTON\_AVE Location: NW

ADA ID: RPAT210921123719 Ramp Type: Type 4 - Parallel Initial Pass/Fail: Fail Overall Compliance: No Severity Score: 16

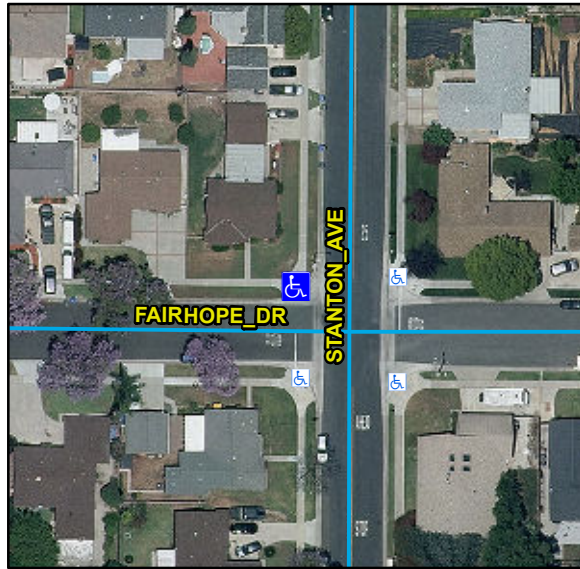
| Compliance | Description | Data | Compliance | Description | Data |
|---|---|---|---|---|---|
| No | Ramp Run Slope LT (%) | 11.1 | Yes | Ramp Run Slope RT (%) | 6.7 |
| No | Ramp Cross Slope LT (%) | 2.6 | Yes | Ramp Cross Slope RT (%) | 0.8 |

Remove & Replace Curb Ramp With Two New Directional Ramps or Equivalent.

R304.3.2, R304.5.3, STD 1115
