# Access Compliance Report Public Rights-of-Way (Curb Ramps)

| Main Street: STANTON_AVE | | Cross Street: FAIRHOPE_DR | | Location: | SW |
| ADA ID: RPAT210921124246 | Ramp Type: Type 4 - Parallel | Initial Pass/Fail: Fail | Overall Compliance: No | Severity Score: | 15 |

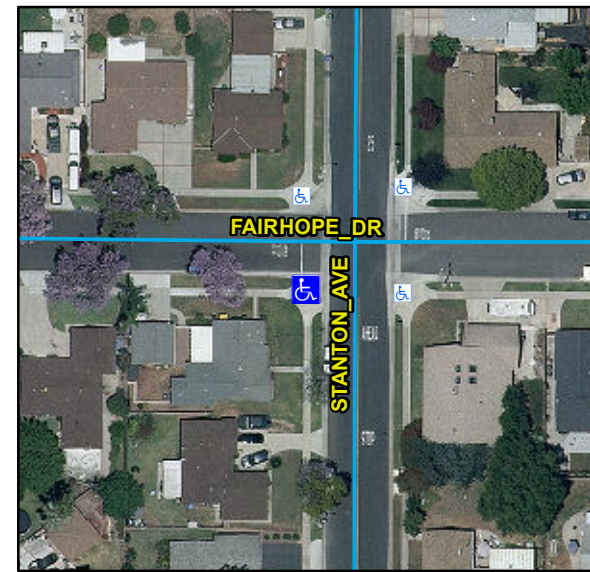
| Compliance | Description | Data | Compliance | Description | Data |
|---|---|---|---|---|---|
| Yes | Ramp Run Slope LT (%) | 6 | No | Ramp Run Slope RT (%) | 9.3 |

**Remove & Replace Curb Ramp With Two New Directional Ramps or Equivalent.**

**R304.3.2, STD 1115**

Total Cost: \$ 4000
