# Access Compliance Report Public Rights-of-Way (Curb Ramps)

| Main Street: FAIRHOPE_DR | | Cross Street: STANTON_AVE | | Location: | SE |
| ADA ID: RPAT210921124546 | Ramp Type: Type 4 - Parallel | Initial Pass/Fail: Pass | Overall Compliance: No | Severity Score: | 6 |

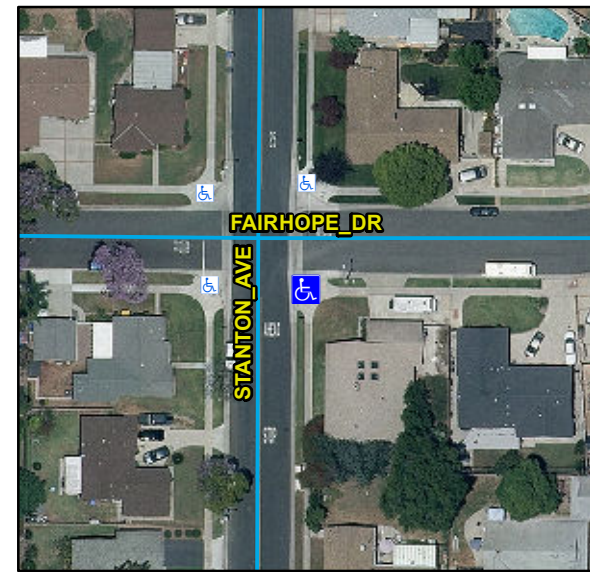
| Compliance | Description | Data | Compliance | Description | Data |
|---|---|---|---|---|---|
| No | Landing Cross Slope (%) | 2.1 | | DWS Offset Type | Single |
| No | Gutter Run Slope (%) | 5.4 | | Road Cross Slope (%) | 1.3 |

**Remove & Replace Landing. Remove & Replace Gutter.**

**R304.5.3, R304.5.4, STD 1115**
