# Access Compliance Report Public Rights-of-Way (Curb Ramps)

| Main Street: STANTON_AVE | | Cross Street: FAIRHOPE_DR | | Location: | NE |
| ADA ID: RPAT210921125034 | Ramp Type: Type 4 - Parallel | Initial Pass/Fail: Fail | Overall Compliance: No | Severity Score: | 2 |

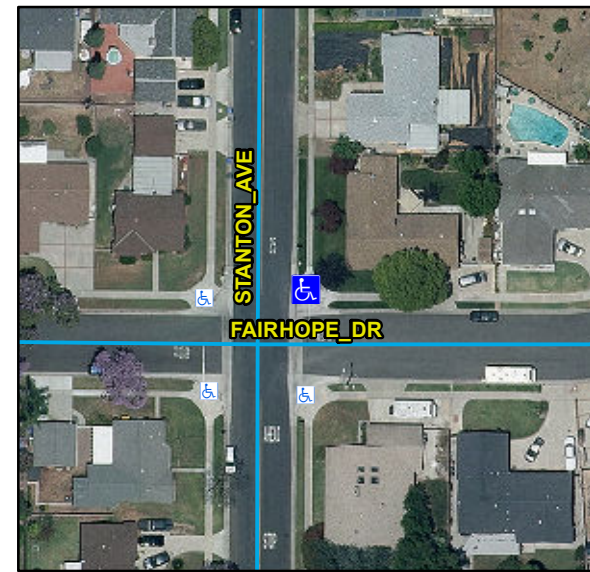
| Compliance | Description | Data | Compliance | Description | Data |
|---|---|---|---|---|---|
| No | Ramp Cross Slope LT (%) | 2.2 | Yes | Ramp Cross Slope RT (%) | 2 |

Possible Solutions:

**Remove & Replace Curb Ramp With Two New Directional Ramps or Equivalent.**

**R304.5.3, STD 1115**

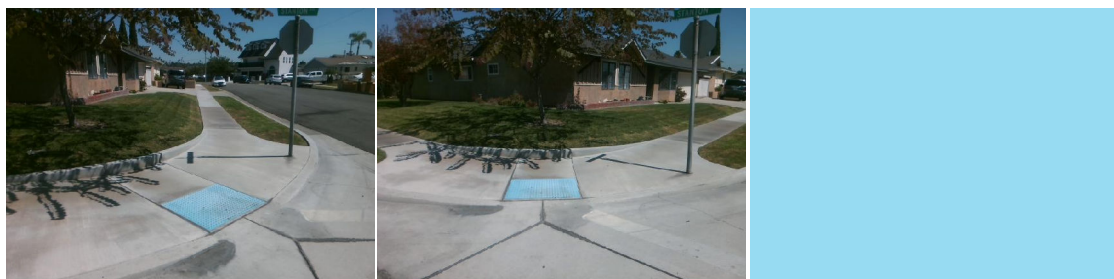
| Compliance | Description | Data | Compliance | Description | Data |
|---|---|---|---|---|---|
| N/A | Ramp Length LT (in) | 112 | N/A | Ramp Length RT (in) | 112 |
| Yes | Ramp Width LT (in) | 102 | Yes | Ramp Width RT (in) | 98 |
| Yes | Ramp Run Slope LT (%) | 7.3 | Yes | Ramp Run Slope RT (%) | 6.8 |
