# Access Compliance Report Public Rights-of-Way (Curb Ramps)

| Main Street: STANTON_AVE | | Cross Street: CARREY_AVE | | Location: | NE |
| ADA ID: RPAT210921125643 | Ramp Type: Type 4 - Parallel | Initial Pass/Fail: Fail | Overall Compliance: No | Severity Score: | 2 |

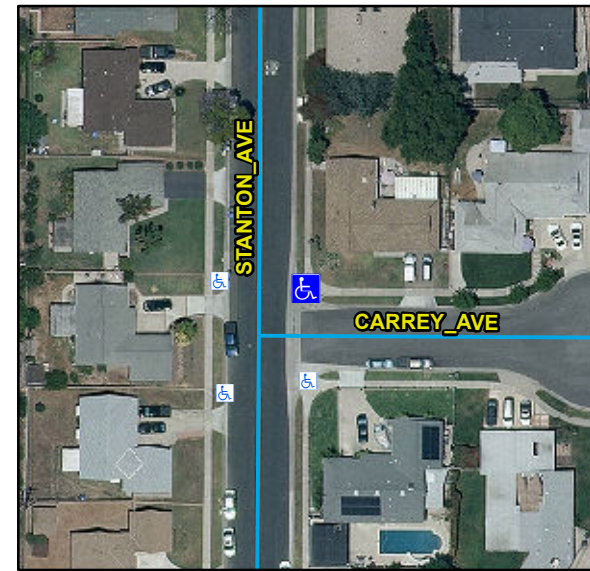
| Compliance | Description | Data | Compliance | Description | Data |
|---|---|---|---|---|---|
| Yes | Ramp Cross Slope LT (%) | 1.6 | No | Ramp Cross Slope RT (%) | 2.7 |

**Remove & Replace Curb Ramp With Two New Directional Ramps or Equivalent.**

**R304.5.3, STD 1115**
