# Access Compliance Report Public Rights-of-Way (Curb Ramps)

Main Street: **CARREY\_AVE** Cross Street: **STANTON\_AVE** Location: **SE**

ADA ID: **RPAT210921125914** Ramp Type: **Type 4 - Parallel** Initial Pass/Fail: **Pass** Overall Compliance: **No** Severity Score: **5**

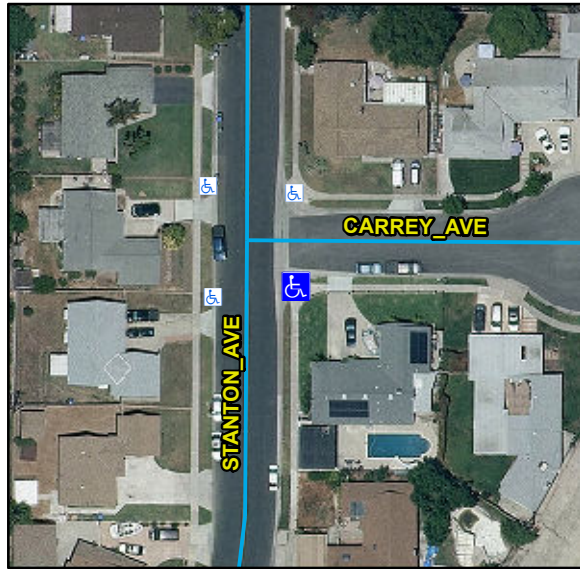
| Compliance | Description | Data | Compliance | Description | Data |
|---|---|---|---|---|---|
| <b>Yes</b> | Gutter Ponding | <b>No</b> | <b>No</b> | Curb Slope | <b>9.1</b> |
| <b>No</b> | Gutter Run Slope (%) | <b>5.3</b> | | Road Cross Slope (%) | <b>2</b> |

**Remove & Replace Curb Slope. Remove & Replace Gutter.**

**R304.2.2, R304.5.4, STD 1115**
