# Access Compliance Report Public Rights-of-Way (Curb Ramps)

Main Street: LYNRIDGE\_DR Cross Street: OLD\_RANCH\_RD Location: NE

ADA ID: RPAT210921141322 Ramp Type: Type 3 - Combination 1 Initial Pass/Fail: Fail Overall Compliance: No Severity Score: 2

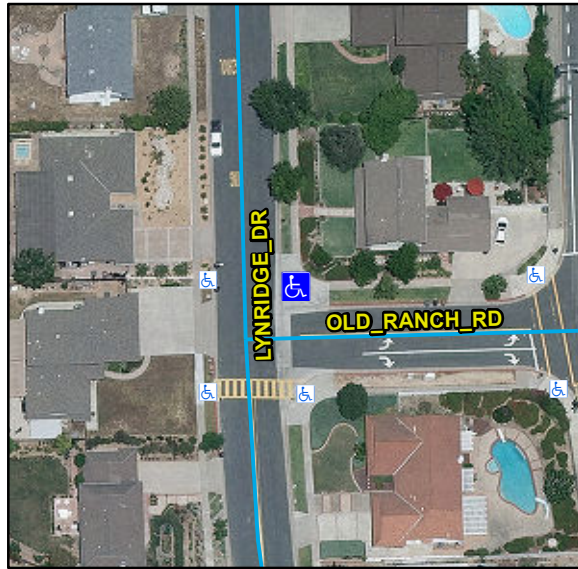
| Compliance | Description | Data | Compliance | Description | Data |
|---|---|---|---|---|---|
| No | Ramp Cross Slope LT (%) | 3.7 | No | Ramp Cross Slope RT (%) | 4.2 |

**Remove & Replace Curb Ramp With Two New Directional Ramps or Equivalent.**

**R304.2.2, R304.5.3, STD 1115**
