# Access Compliance Report Public Rights-of-Way (Curb Ramps)

Main Street: OLD\_RANCH\_RD Cross Street: LYNRIDGE\_DR Location: SE

ADA ID: RPAT210921142044 Ramp Type: Type 3 - Combination 1 Initial Pass/Fail: Fail Overall Compliance: No Severity Score: 30

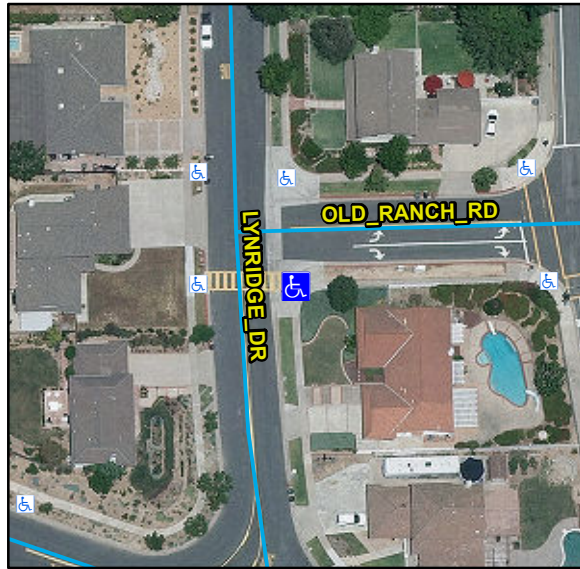
| Compliance | Description | Data | Compliance | Description | Data |
|---|---|---|---|---|---|
| No | Ramp Run Slope LT (%) | 11.9 | Yes | Ramp Run Slope RT (%) | 0.9 |
| No | Ramp Cross Slope LT (%) | 4.7 | No | Ramp Cross Slope RT (%) | 6.2 |
| No | Ramp Cross Slope (%) | 5.6 | N/A | Flare Traversable LT | N/A |

Remove & Replace Curb Ramp With Two New Directional Ramps or Equivalent.

R304.2.2, R304.5.3, R304.3.2, STD 1115
