# Access Compliance Report Public Rights-of-Way (Curb Ramps)

| Main Street: FAIRMONT_BLV | | Cross Street: OLD_RANCH_RD | | Location: | SW |
| ADA ID: RPAT210921143532 | Ramp Type: Type 4 - Parallel | Initial Pass/Fail: Pass | Overall Compliance: No | Severity Score: | 5 |

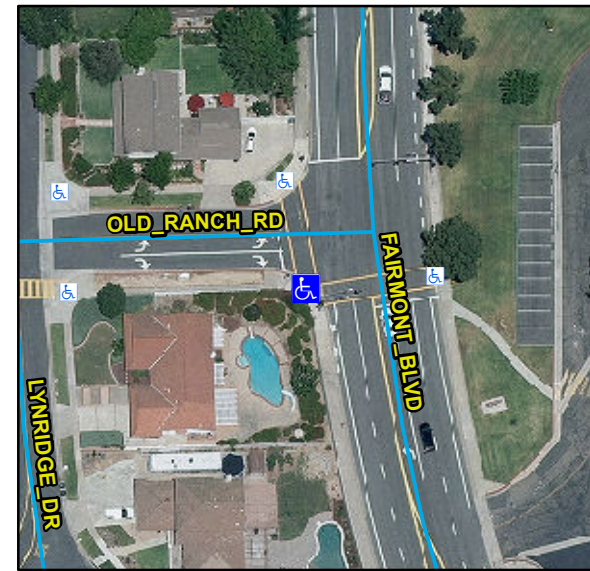
| Compliance | Description | Data | Compliance | Description | Data |
|---|---|---|---|---|---|
| No | Gutter Run Slope (%) | 6 | | Road Cross Slope (%) | 3.4 |

Remove & Replace Gutter.

R304.5.4, STD 1115
