# Access Compliance Report Public Rights-of-Way (Curb Ramps)

Main Street: FAIRMONT\_BLV Cross Street: OLD\_RANCH\_RD Location: SE

ADA ID: RPAT210921144540 Ramp Type: Type 4 - Parallel Initial Pass/Fail: Fail Overall Compliance: No Severity Score: 2

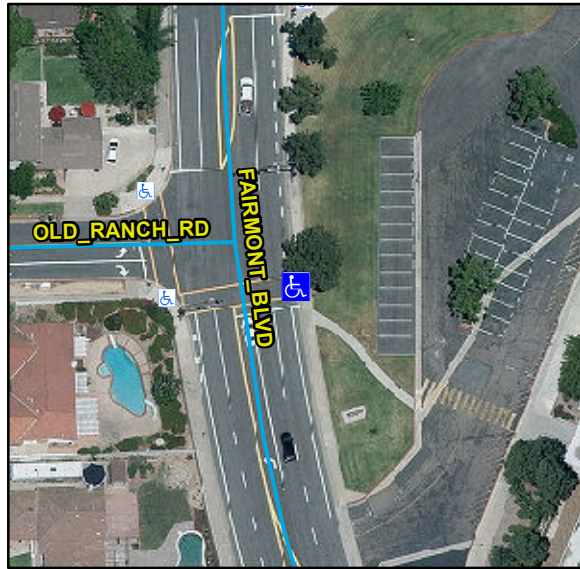
| Compliance | Description | Data | Compliance | Description | Data |
|---|---|---|---|---|---|
| No | Ramp Cross Slope LT (%) | 3.2 | No | Ramp Cross Slope RT (%) | 2.9 |

Remove & Replace Entire Ramp.

R304.5.3, STD 1115
