# Access Compliance Report Public Rights-of-Way (Curb Ramps)

Main Street: FAIRMONT\_BLV D Cross Street: FUTURA\_DR Location: NE

ADA ID: RPAT210921152506 Ramp Type: Type 4 - Parallel Initial Pass/Fail: Fail Overall Compliance: No Severity Score: 15

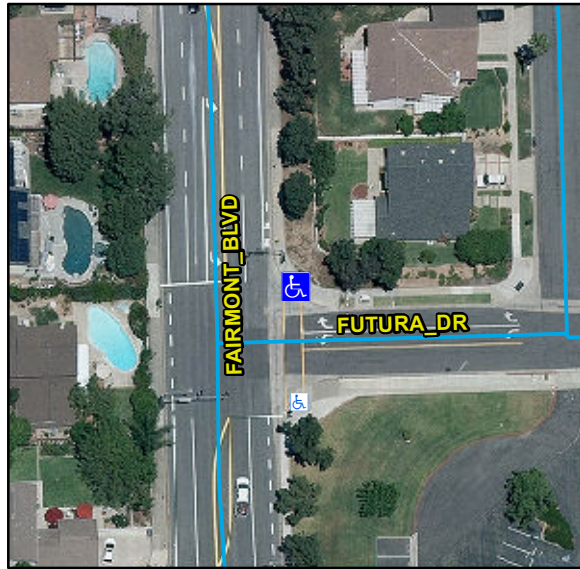
| Compliance | Description | Data | Compliance | Description | Data |
|---|---|---|---|---|---|
| Yes | Ramp Run Slope LT (%) | 8.1 | No | Ramp Run Slope RT (%) | 10.7 |

**Remove & Replace Curb Ramp With Two New Directional Ramps or Equivalent.**

**R304.3.2, STD 1115**
