# Access Compliance Report Public Rights-of-Way (Curb Ramps)

Main Street: PASATIEMPO\_DR Cross Street: OLD\_RANCH\_RD Location: NE

ADA ID: RPAT210922080526 Ramp Type: Type 3 - Combination 1 Initial Pass/Fail: Fail Overall Compliance: No Severity Score: 4

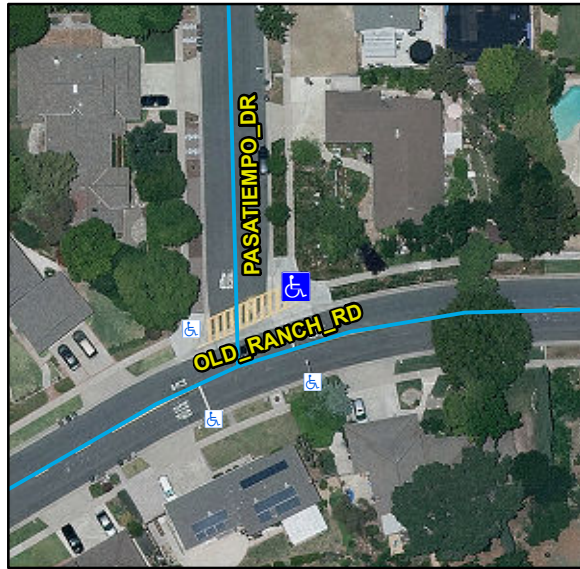
| Compliance | Description | Data | Compliance | Description | Data |
|---|---|---|---|---|---|
| Yes | Ramp Width LT (in) | 50 | No | Ramp Width RT (in) | 47 |
| N/A | Gutter Ponding | N/A | No | Curb Slope | 9.3 |

Remove & Replace Curb Ramp With Two New Directional Ramps or Equivalent.

R304.2.2, R304.5.1, STD 1115
