# Access Compliance Report Public Rights-of-Way (Curb Ramps)

Main Street: OLD\_RANCH\_RD Cross Street: PASATIEMPO\_DR Location: NW

ADA ID: RPAT210922081148 Ramp Type: Type 1 - Perpendicular Diagonal Initial Pass/Fail: Fail Overall Compliance: No Severity Score: 15

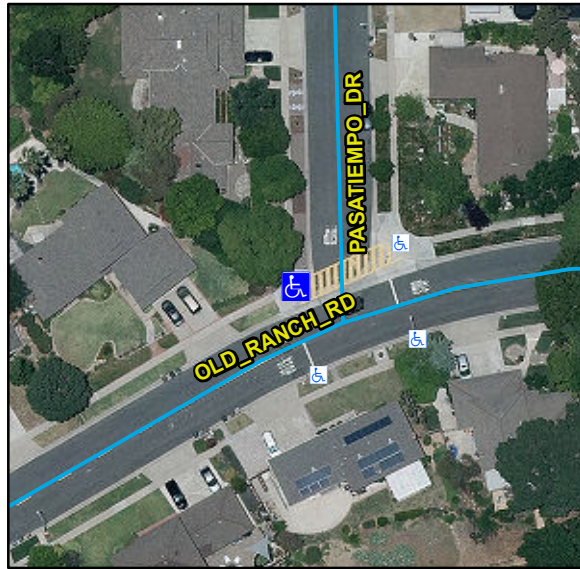
| Compliance | Description | Data | Compliance | Description | Data |
|---|---|---|---|---|---|
| No | Ramp Cross Slope (%) | 5.1 | N/A | Flare Traversable LT | N/A |

Remove & Replace Curb Ramp With Two New Directional Ramps or Equivalent.

R304.2.2, R304.5.3, STD 1115
