# Access Compliance Report Public Rights-of-Way (Curb Ramps)

Main Street: OLD\_RANCH\_RD Cross Street: MARYNELL\_DR Location: NW

ADA ID: RPAT210922081845 Ramp Type: Type 3 - Combination 1 Initial Pass/Fail: Pass Overall Compliance: No Severity Score: 6

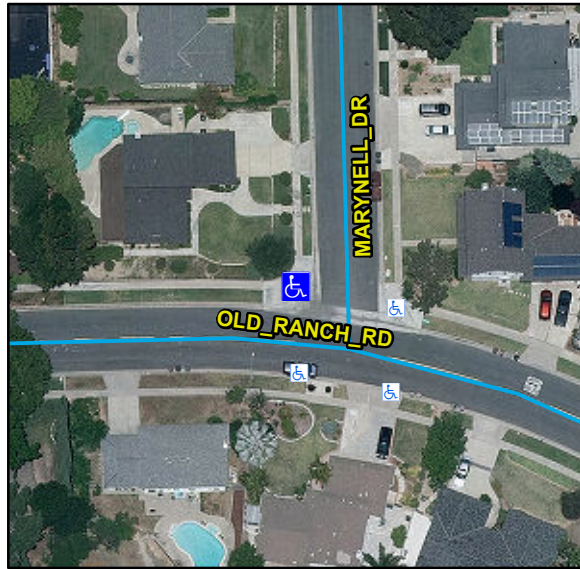
| Compliance | Description | Data | Compliance | Description | Data |
|---|---|---|---|---|---|
| No | Landing Length (in) | 40 | | | Sloped |
| No | Gutter Cross Slope (%) | 3.2 | | | |

**Remove & Replace Landing. Remove & Replace Gutter.**

**R304.2.1, R304.5.3, STD 1115**
