# Access Compliance Report Public Rights-of-Way (Curb Ramps)

Main Street: MARYNELL\_DR Cross Street: OLD\_RANCH\_RD Location: NE

ADA ID: RPAT210922082629 Ramp Type: Type 3 - Combination 1 Initial Pass/Fail: Fail Overall Compliance: No Severity Score: 4

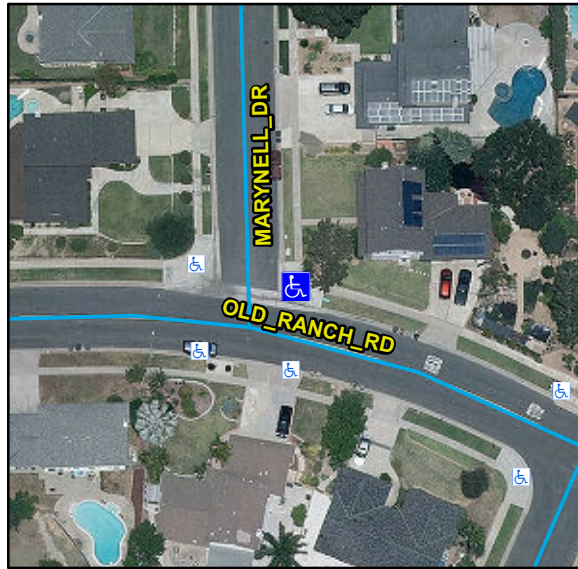
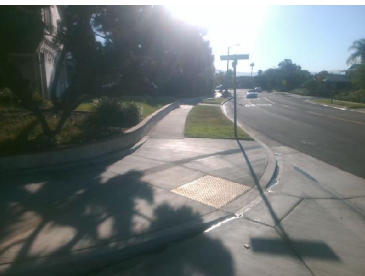
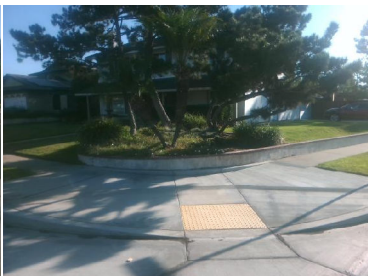
| Compliance | Description | Data | Compliance | Description | Data |
|---|---|---|---|---|---|
| No | Ramp Width LT (in) | 40 | Yes | Ramp Width RT (in) | 51 |
| N/A | Gutter Ponding | N/A | No | Curb Slope | 5.6 |

**Remove & Replace Curb Ramp With Two New Directional Ramps or Equivalent. Remove & Replace Sidewalk.**

**R304.2.2, R304.5.1, STD 1115**
